A PROCESS TO DIGITALLY MAP HELICOPTER MAIN ROTOR BLADES IN SUPPORT OF CONDITION BASED ACQUISITION AND SUSTAINMENT ACTIVITY

JOINT APPLIED PROJECT REPORT

September 2021

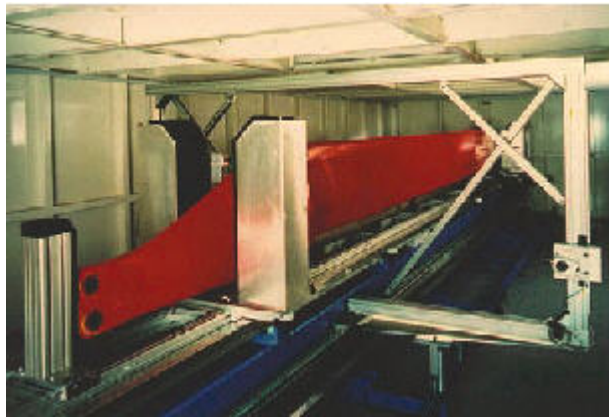
Figure 12. Shearography Applied to a Rotor Blade Inside a Vacuum Chamber. Source: Krupka (2003)

platform on one end while the opposite side of the MRB is coupled to a torque motor that would provide the stressing required by shearography. Understanding the MRB stress limits would need to be taken into careful consideration to ensure no damage to the rotor blade. Cameras could be placed in multiple locations to provide a 360° view of the MRB while subjected to light waves. An article written in 2003 by R. Krupka, T. Waltz, and A. Ettemeyer regarding the *Industrial Applications of Shearography for Inspection of Aircraft Components* validates shearography as an improved non-destructive test (NDT) for aircraft components, specifically helicopter rotor blades. This article provides examples of shearography being applied as inspection methods for rotor blades as seen in Figure 12. Figure 12 shows an inspection of a helicopter rotor blade inside a vacuum chamber that is using shearography to detect any deformations and/or delamination (Krupka, 2003). In this particular example, the vacuum chamber is applying the stress required to conduct a non-destructive shearography test.

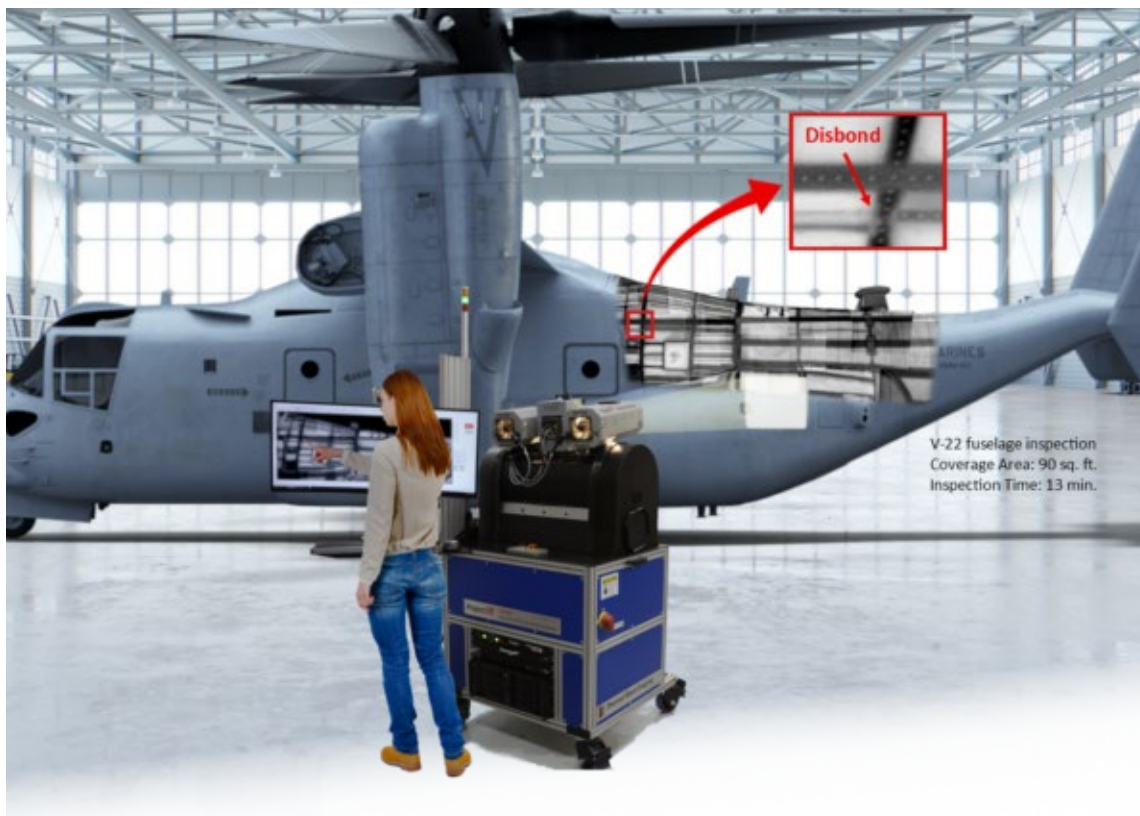
Figure 15. Large Area Inspection Concept as presented on the TWI website.
Source: TWI, <https://www.thermalwave.com/technology/>.

With improvements in instrumentation that can be used to conduct thermography scans, a leading industry organization Thermal Wave Imaging (TWI) is pushing the limits for how thermography is used in the defense industry. Like shearography, thermography is also a NDT that can be used to detect anomalies or defects of composite materials. As depicted in Figure 15, TWI is pushing to advance inspection techniques in the field even with new and emerging weapon systems such as the future vertical lift platforms. Although Figure 15 shows an inspection on the body of an aircraft, according to TWI the technology is best fit to inspect composite images for impact damage, delaminations, water ingress, foreign object debris detection, thickness measurement, porosity, and disbonds (TWI, n.d.). Similar to the honeycomb structure of a rotor blade, TWI shows an example on their website, Figure 16, of how thermography can assist in detecting trapped water internal to a honeycomb structure.
